# COMMERCIAL ROOF CONDITION ASSESSMENT

AERIAL SURVEY & RISK ANALYSIS REPORT

**Client:** Sample Client / Demonstration  
**Site Location:** Commercial Outbuilding  
**Survey Date:** March 2026  
**Inspector:** Rob Andrews

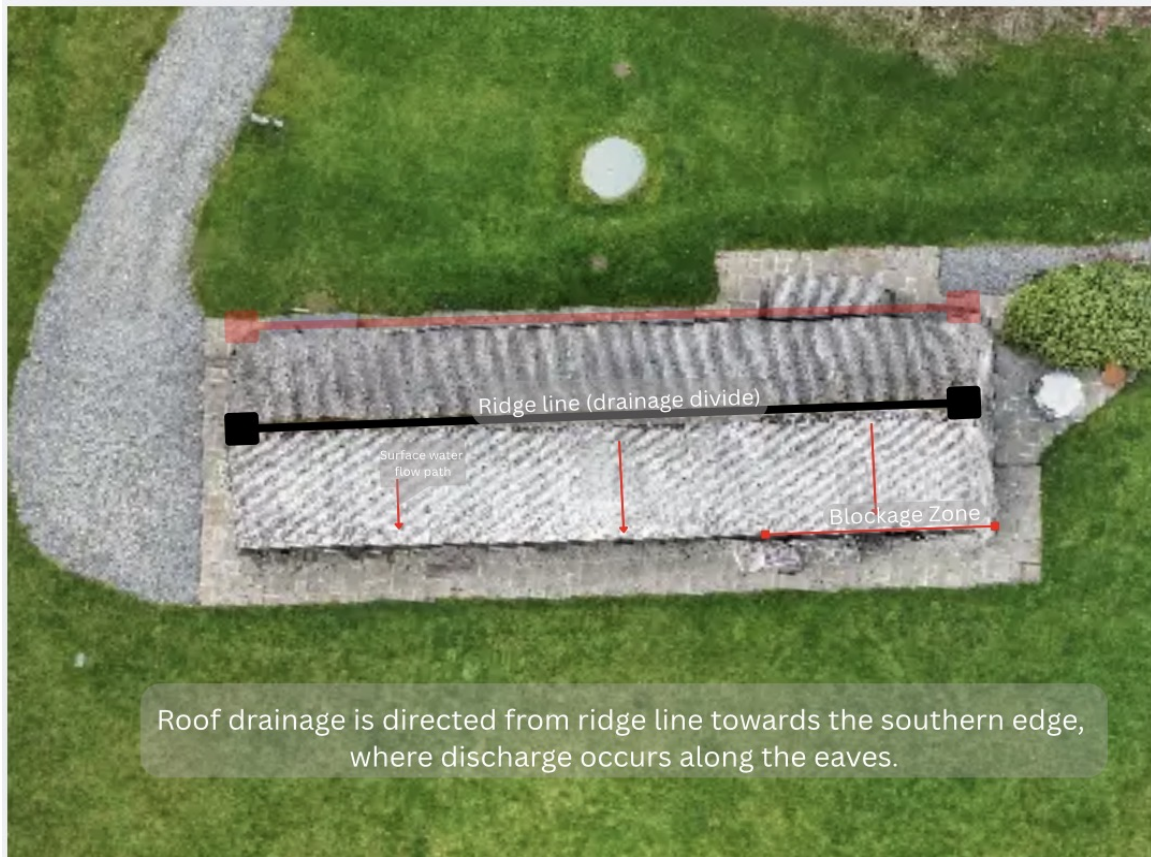
## 2. Drainage Flow Analysis

Understanding how water interacts with the roof structure is critical for preventing internal dampness and structural rot. The diagram below illustrates the surface water flow paths from the drainage divide (ridge line) towards the southern eaves.

All surface water is correctly directed towards the southern edge. However, the identified 'Blockage Zone' at the eaves prevents discharge. During heavy rainfall, this will result in immediate overflow. If unaddressed, this will accelerate material degradation and increase the likelihood of water ingress within 12–24 months, potentially invalidating commercial insurance policies.

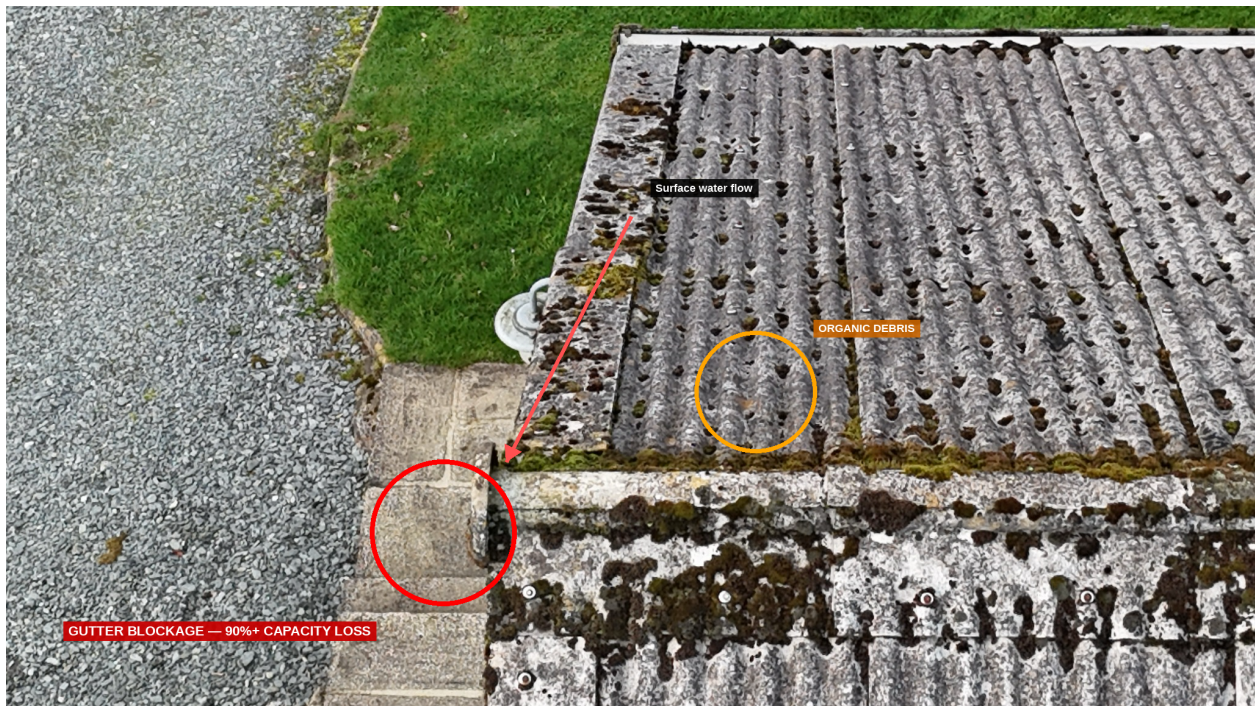
## Defect 01 – Blocked Gutter (South Eaves)

<b>Location:</b>	South-facing eaves edge
<b>Severity:</b>	<b>CRITICAL</b>
<b>Description:</b>	Total obstruction of the gutter channel by organic debris, resulting in a 90%+ capacity reduction.
<b>Cause:</b>	Long-term accumulation of moss and leaf matter washing down from the corrugated roof surface.
<b>Consequence:</b>	Immediate risk of overflow during heavy rainfall. If unaddressed, water will track back under the roof sheets via capillary action, leading to internal water penetration and potential stock/asset damage within 12 months.

- 1. Drainage Restoration:** Clearance of organic debris from the southern eaves guttering is required to restore full drainage function and mitigate overflow risk.
- 2. Surface Maintenance:** Removal of vegetative ingress from the corrugated sheets is advised to halt accelerated material degradation.
- 3. Re-inspection:** A follow-up aerial survey is recommended in 12 months to verify the condition of the exposed fixings and monitor surface deterioration.

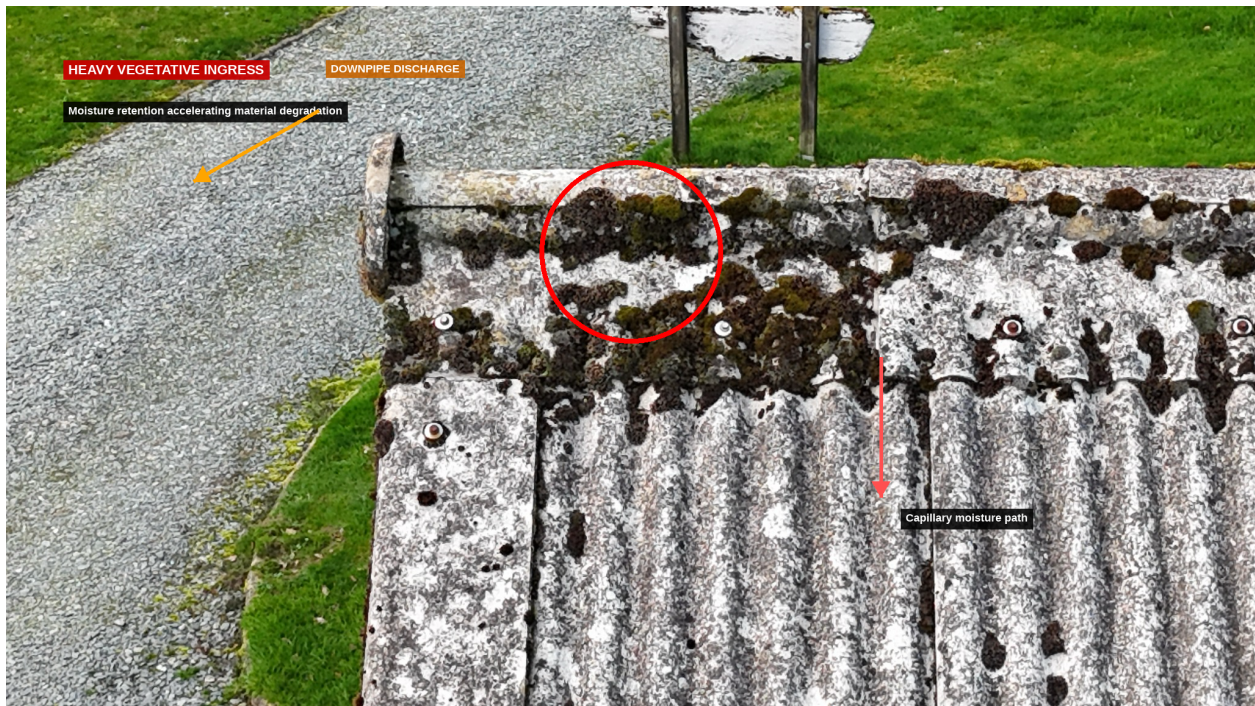
## Defect 02 – Heavy Vegetative Ingress

<b>Location:</b>	Across the lower third of the southern roof pitch
<b>Severity:</b>	<b>HIGH</b>
<b>Description:</b>	Extensive moss and lichen growth firmly attached to the corrugated sheet surface and gathering at the eaves.
<b>Cause:</b>	Lack of preventative maintenance combined with a shaded, damp microclimate.
<b>Consequence:</b>	Moss acts as a sponge, retaining moisture against the roof surface. If unaddressed, this will accelerate the degradation of the sheet material and significantly reduce the lifespan of the roof covering.

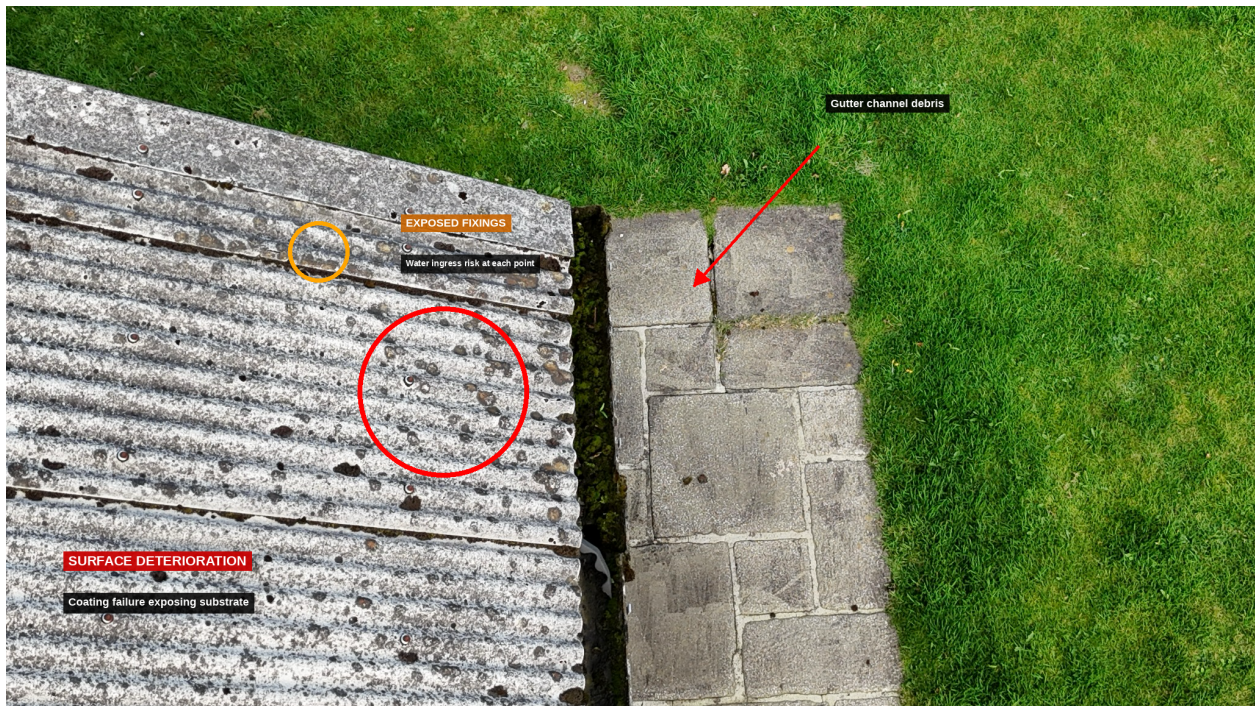
## Defect 03 – Surface Deterioration & Exposed Fixings

<b>Location:</b>	South-western corner of the roof structure
<b>Severity:</b>	MEDIUM
<b>Description:</b>	Failure of the protective surface coating on the corrugated sheets, exposing the underlying substrate and fixing points.
<b>Cause:</b>	Weathering, UV exposure, and prolonged contact with retained moisture from vegetative ingress.
<b>Consequence:</b>	Exposed fixings present a high probability of localized water ingress. If unaddressed, this will lead to fixing corrosion and potential structural loosening in high wind events.

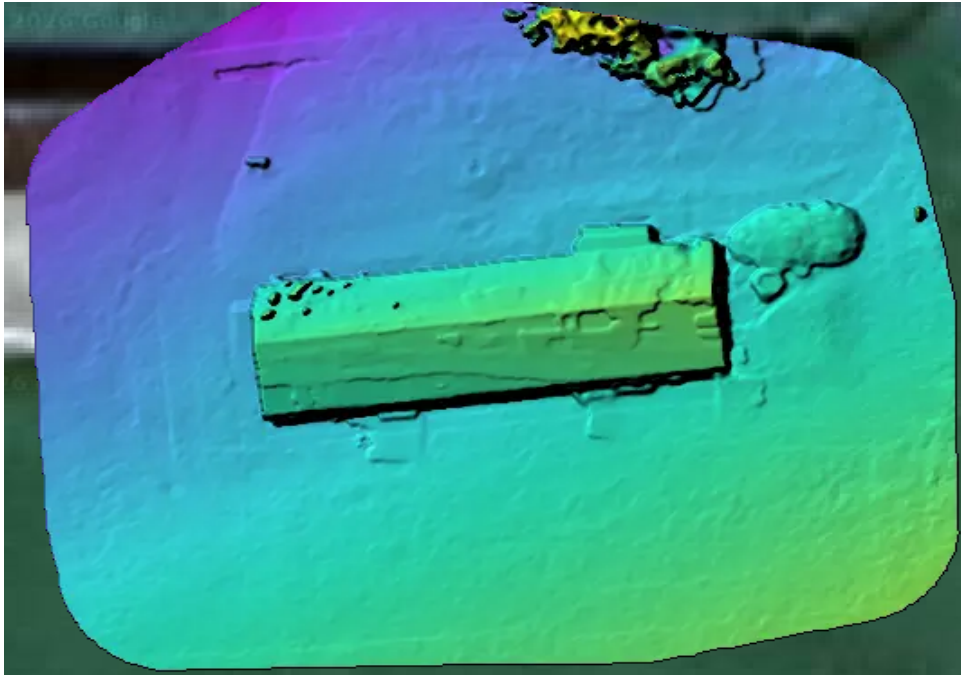
### Digital Surface Model (DSM)

The DSM creates a detailed elevation model of the roof, visualized as a color-coded heat map. This data is invaluable for predicting drainage failures and verifying slope pitch. In this survey, it confirms the structural integrity of the pitch, highlighting that the drainage failure is entirely due to vegetative obstruction, not structural sagging.
