# COMMERCIAL ROOF CONDITION ASSESSMENT

AERIAL SURVEY & RISK ANALYSIS REPORT

**Client:** Sample Client / Demonstration  
**Site Location:** Commercial Outbuilding  
**Survey Date:** March 2026  
**Inspector:** Rob Andrews

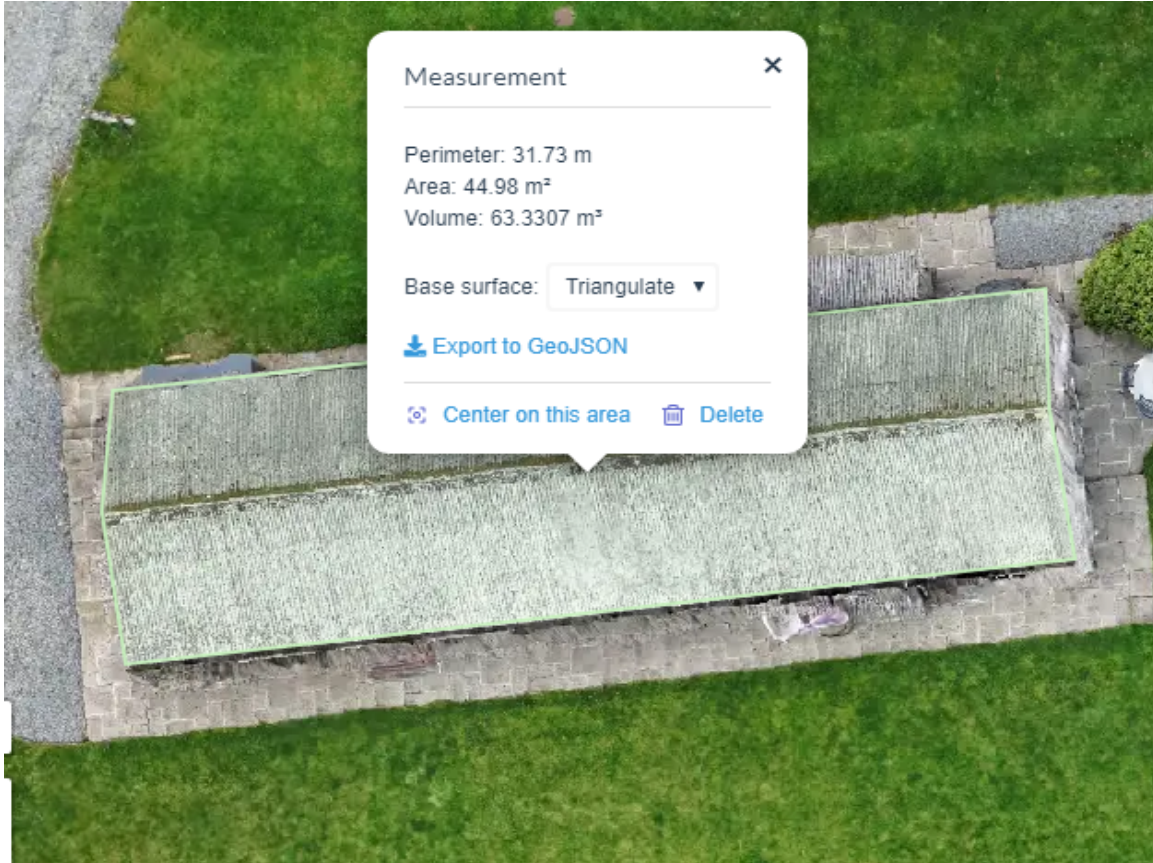
### High-Resolution Orthomosaic (0.27 cm/pixel GSD)

The image above demonstrates our measurement capabilities on the high-resolution 2D orthomosaic map. This level of detail allows for precise identification of features and potential issues across the entire asset.

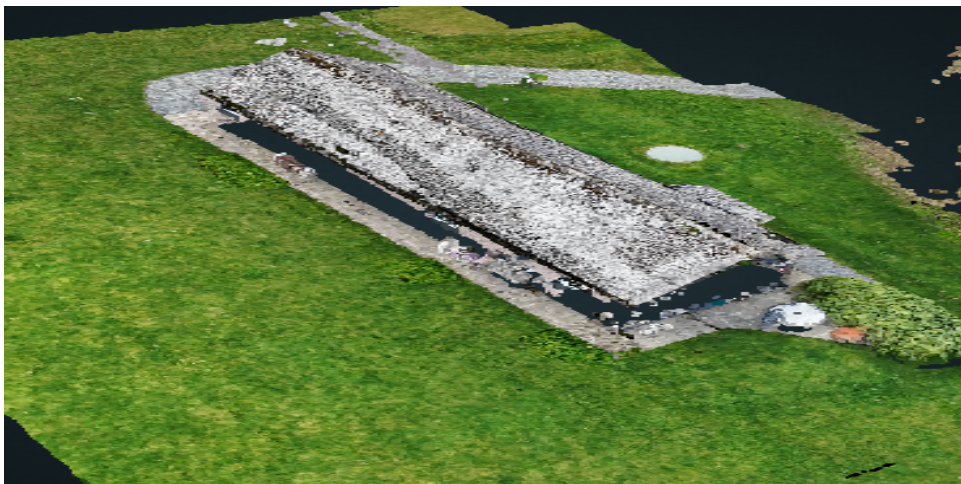
### 3D Interactive Mesh

A fully interactive 3D model is provided to the client via a secure web link. This asset allows maintenance teams to virtually inspect the site, plan safe access routes (e.g., scaffolding placement), and assess health and safety risks prior to arriving on site, significantly reducing preliminary survey costs.
